POST-FIRE EVALUATION

REPORT OF FINDINGS

COLLINS RESIDENCE

1312 WEST 60TH STREET NORTH MUSKOGEE, OKLAHOMA 74403

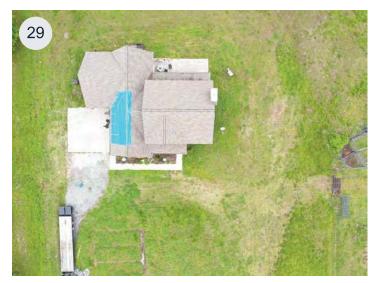
Overview of the roof surface from a Valor FES UAV (drone).

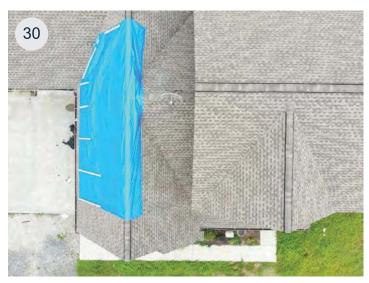
Closer view of the portions of the roof surfaces covered by the blue tarp. $\,$

- Removal and reconstruction of the laminate-style asphalt-composition shingle roof surfaces in their entirety. It will also be necessary to remove and replace the reflective OSB roof sheathing.
